August 21, 2015

Stillwater County Board of Commissioners
400 East 3rd Avenue North
Columbus, Montana 59019

Subject: Stillwater River Road Rockfall Hazard Summary

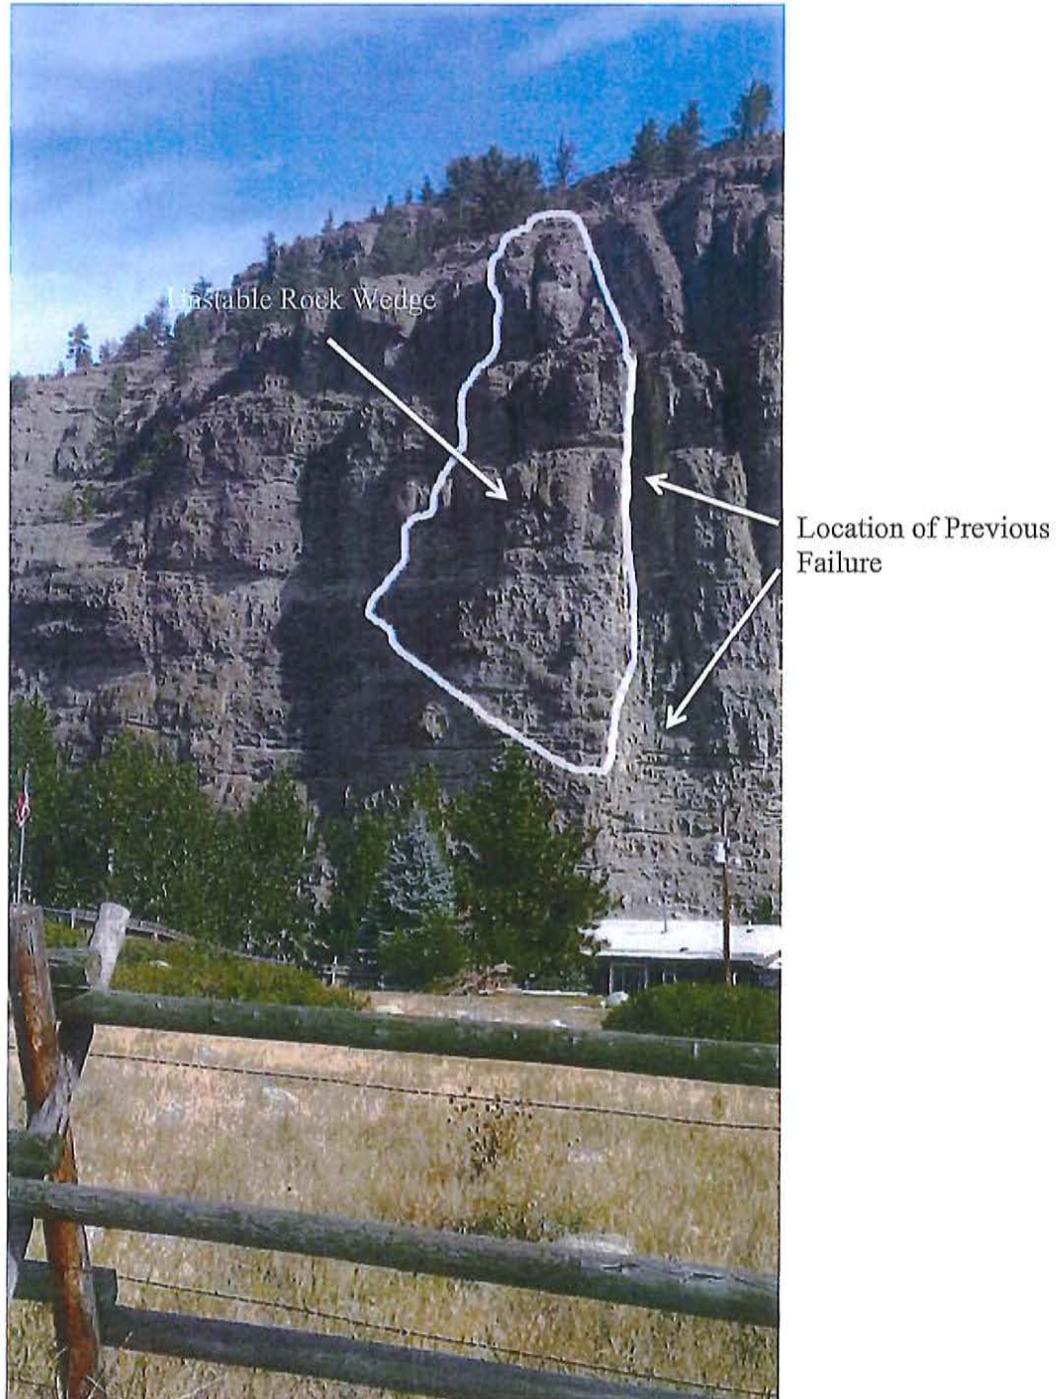
The previous rockfall failure was caused by mobilization of a large rock wedge that increased the stresses on the adjacent mass to the right, and caused failure that deposited significant debris (approximately 150 tons) on the road and into the river. Remaining on the slope is a much larger rock mass (greater than 10 times the weight) in the shape of a wedge that remains on the near vertical slope in an unstable configuration. This image of the failed section and unstable wedge are shown in subsequent figures. Signs of distress on this mass are visible and leads to the conclusion that failure of this large wedge will occur; however, there is not a scientific method to determine the exact timeframe in which it will occur. Our best judgment would put it within the next 10-15 years, but could just as likely be within the next year. It is most prone for failure after a significant rain event or during the freeze-thaw process in the spring.

Figure 1: Frontal View Outline of Unstable Rock Wedge

This large unstable mass poses a significant hazard to the road users, the adjacent river, and potentially nearby dwellings across the river. GSI recommends that the road remain closed until rockfall remediation is completed.

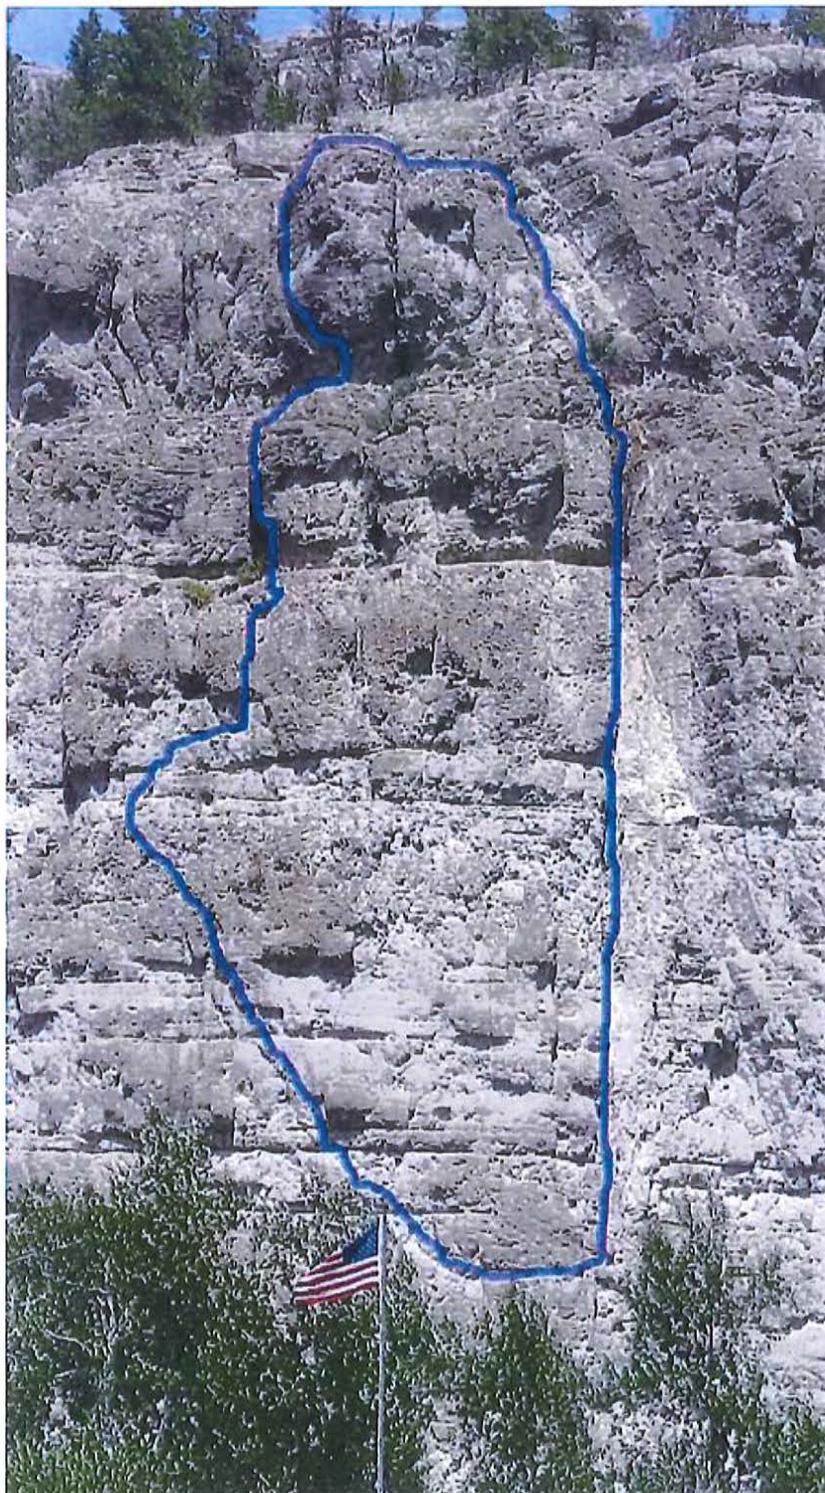
Figure 2: Up Close View of Unstable Rock Wedge Left of Previously Failed Block

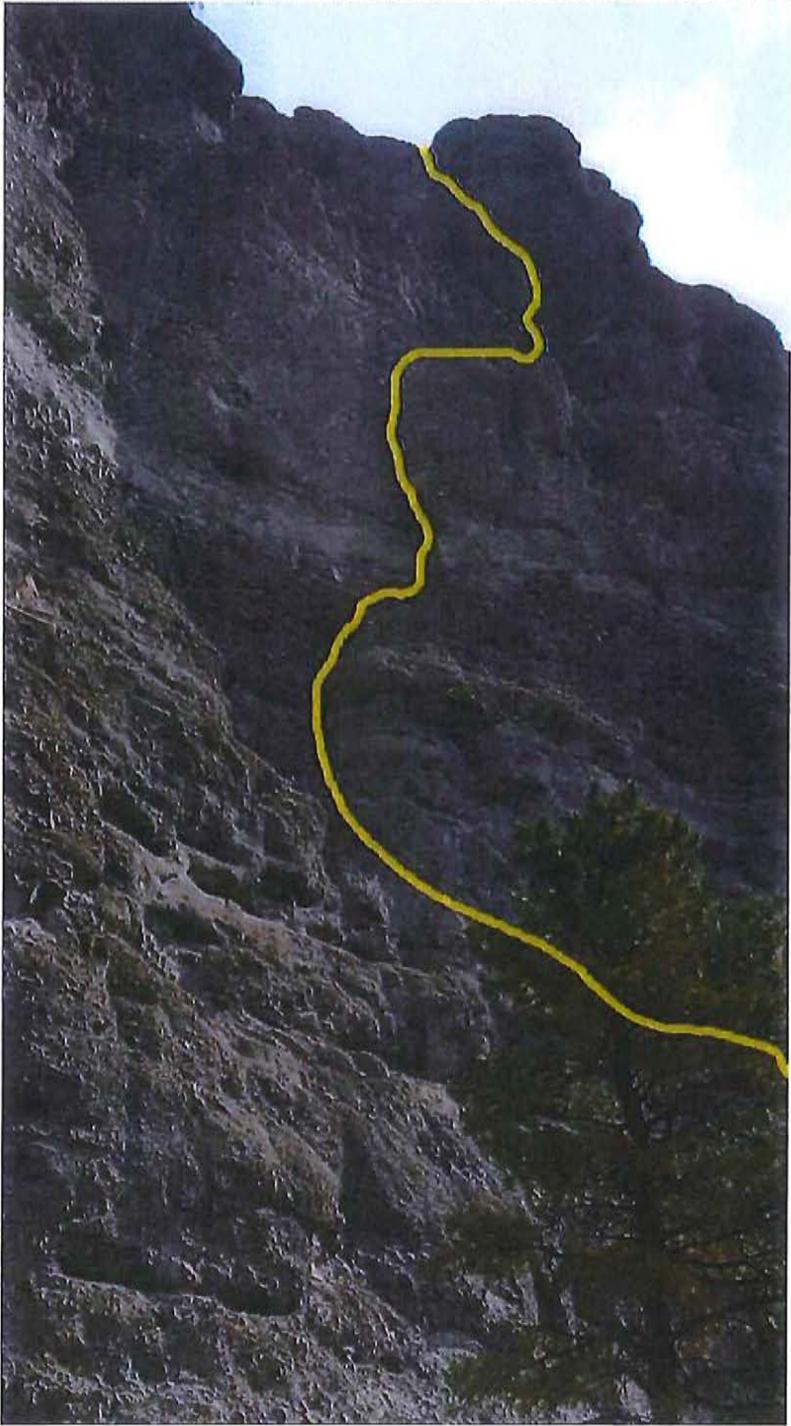
Figure 3: Failure Plane on Left Side of Unstable Rock Wedge
