June 15, 2015

Project 15-3359G

Re: Geotechnical Reconnaissance, Stillwater River Road Rock Slide, West of Absarokee, Montana

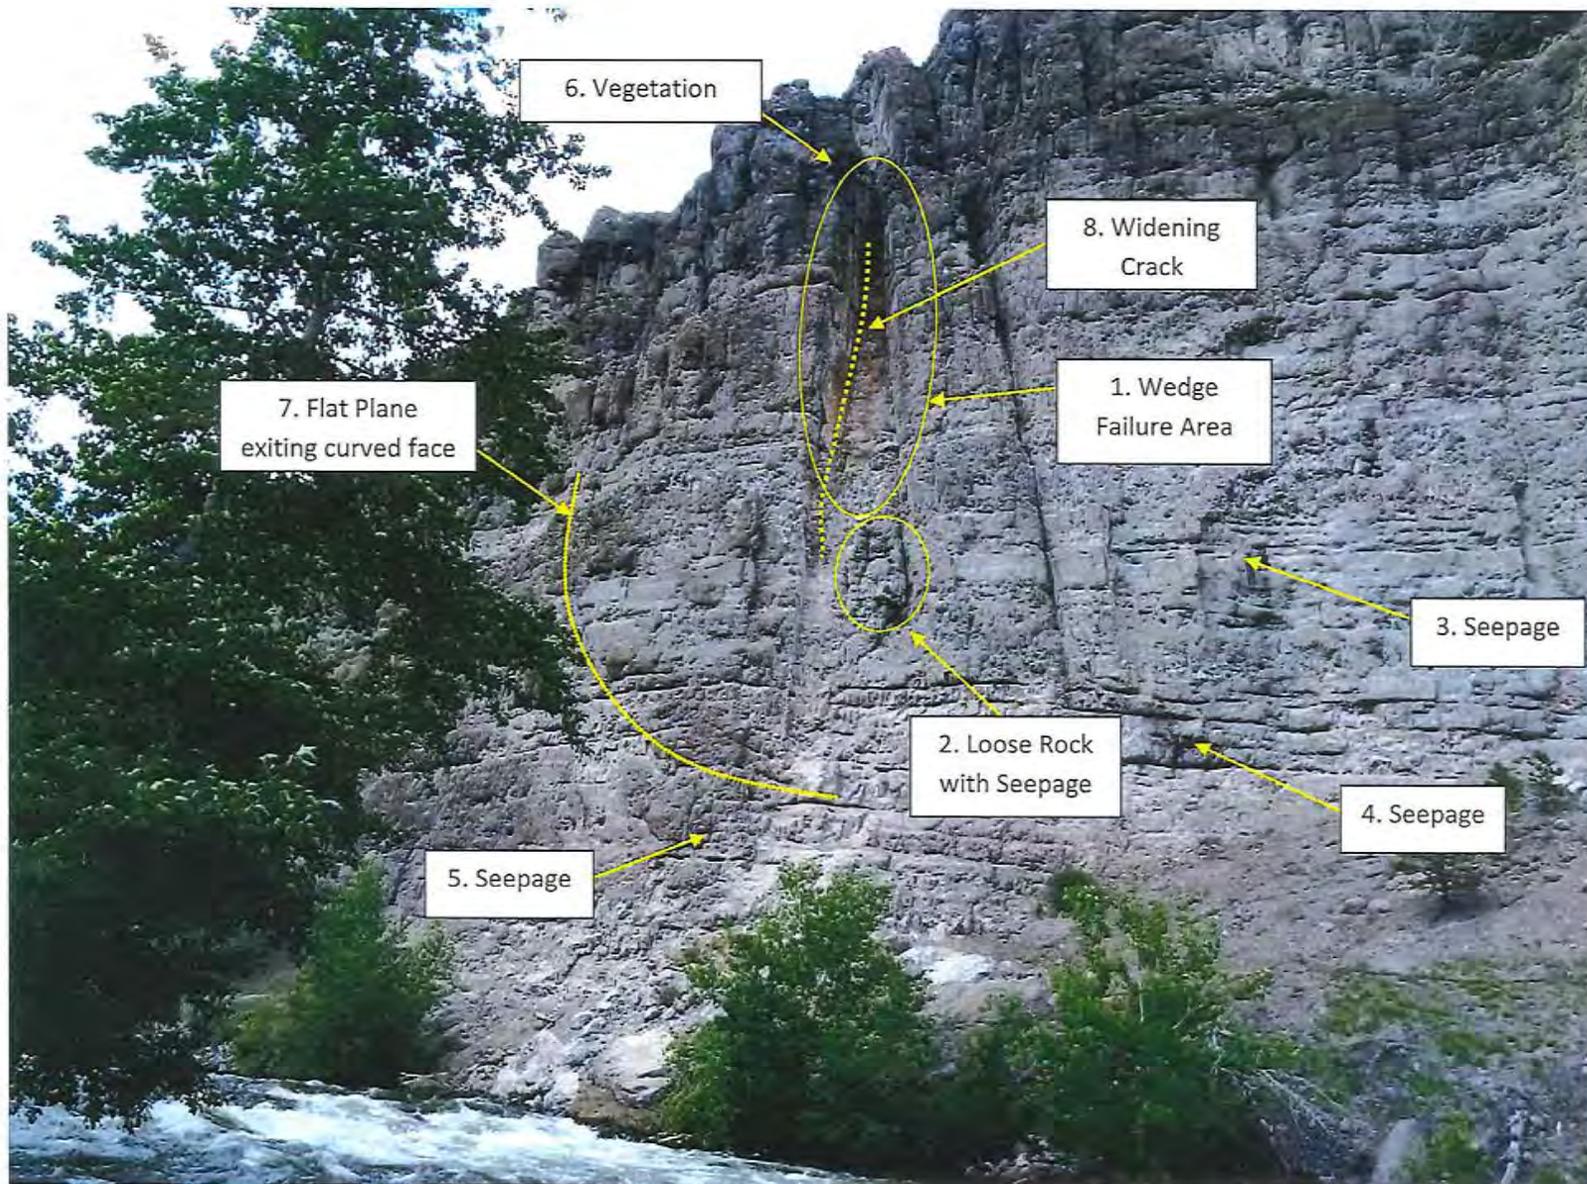
Figure 1

The rock slide was a wedge-shaped failure approximately 50 feet long, 5 to 10 feet wide and about 5 feet deep. The wedge failure is labeled #1 on the attached photos. The bottom of the failure was about 30 to 40 feet above the roadway. In the area around the rock slide, Stillwater River Road travels beneath the rock face, which is approximately 100 to 150 feet tall and 1/4-mile long in total. There is no shoulder either between the road and the rock face or the road and the slope leading down to the Stillwater River. The Stillwater River is about 15 feet below the road surface elevation with an approximately 1H:1V slope between the river and the road.

In several areas around the rock slide, water was observed seeping from the rock face. These active seeps were located approximately 10 to 15 feet away from the wedge failure and are labeled as #3, #4, and #5. Label #2 is a portion of rock hanging just below the wedge failure. It was observed to be damp and possibly seeping, but dripping water was not observed. While on site, we also observed clouds of dust escaping from joints in the rock near label #2. This suggests very loose rock and active movement was occurring.

Above the wedge failure area, vegetation was observed, which indicates a relative flat spot (perhaps a ledge) above the wedge failure having enough moisture to establish plants. This likely allowed water to accumulate behind the failed wedge. This water can saturate the rock increasing its weight, and when combined with the joint lubrication, likely contributed to the rock wedge failure.

Numerous areas of the outcrop appear to be unstable. In the vicinity of label #2, several suitcase-sized rocks were observed which appeared to be relatively loose. Outside of the immediate wedge failure area, other portions of the rock face appear to have a high risk of wedge failures in the future. Areas #9 and #10 have discontinuities that intersect to create a wedge. They appear to be relatively stable when compared to the loose rocks in area #2, but the risk of failure still exists. A large rock mass is defined by the discontinuity shown with lines labeled #7 and #8. These discontinuities represent failure planes, and although no active movement was observed, there is a risk of future failure. This risk increases due to water saturation and seismic events.

During the reconnaissance, it was our opinion the road should remain closed due to the recent movement observed in the vicinity of label #2. We recommended monitoring of the observed seeps to assist in evaluating when to clear the debris and open the road.

The proximity of this rock face to Stillwater County Road and residences represents a significant hazard to people and property. It should be noted, the rock face has always had a risk of failure and subsequent hazardous conditions. The risk of failure increases seasonally with the highest risk coming in the spring with heavy snow melt and spring rains. A seismic event (earthquake) is one of the highest risks for rock slides to occur along the rock face. It is our opinion the rock face is currently at a slightly higher risk of failure than it was one day before failure due to the visible seeps. When these seeps are no longer visible, then it is our opinion the risk of failure is basically the same as it was before the recent rock slide. Assuming some risk is acceptable, then it is our opinion the road can be cleared and opened when the visible seeps are no longer apparent.

The only way to eliminate these risks is to close or relocate the roadway. Closing the roadway would force residents west of the failure area to take an alternate route, while relocating the road would require building two bridges and a new section of County road. Residents living in the area should be informed of the risk of rock slides and the hazardous condition they create. We recommend "rock fall" signage be placed along the road to warn the public of the risk. Great West Engineering can assist in determining the proper signage.
