## Geologic Setting of the Stillwater River Rockfall

September 11, 2015

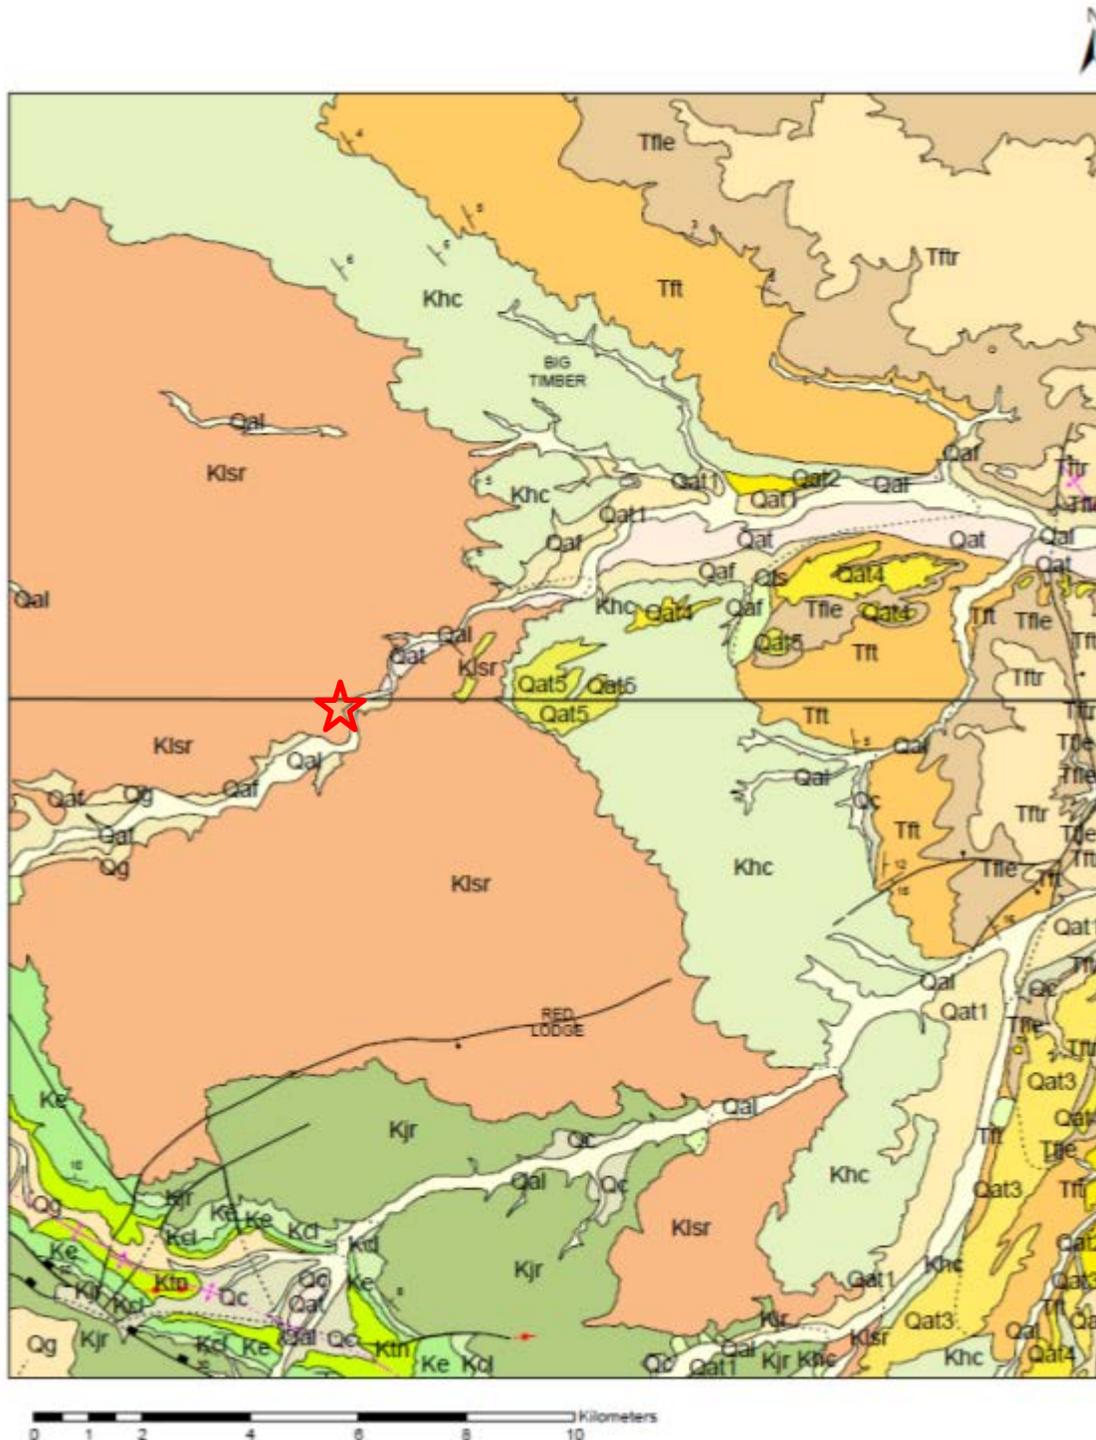
Figure 1. Geologic map showing various rock types surrounding the Stillwater River road rockfall (marked by red star). The orange unit labeled Klsr is the Sliderrock Mountain formation. Units labeled Qat—alluvial terrace, Qal—alluvium, Qaf—alluvial fan, and Qg—glacial deposits are recent (Quaternary) deposits along the Stillwater River valley. The complete Red Lodge and Big Timber geologic maps are available from: <http://www.mbm.mtech.edu/gmr/gmr-statemap.asp#quadmaps>.

The Stillwater River rockfall site is located along the Stillwater River Road, County Route 420, 2.9 miles northeast of the community of Beehive and 12.5 miles west of the town of Absaroka, Montana. At this location, the Stillwater River has eroded a canyon up to 350 feet deep into the surrounding bedrock of the Sliderock Mountain formation, an informal member of the Upper Cretaceous (100-million to 65-million years old) Livingston Group (Figure 1).

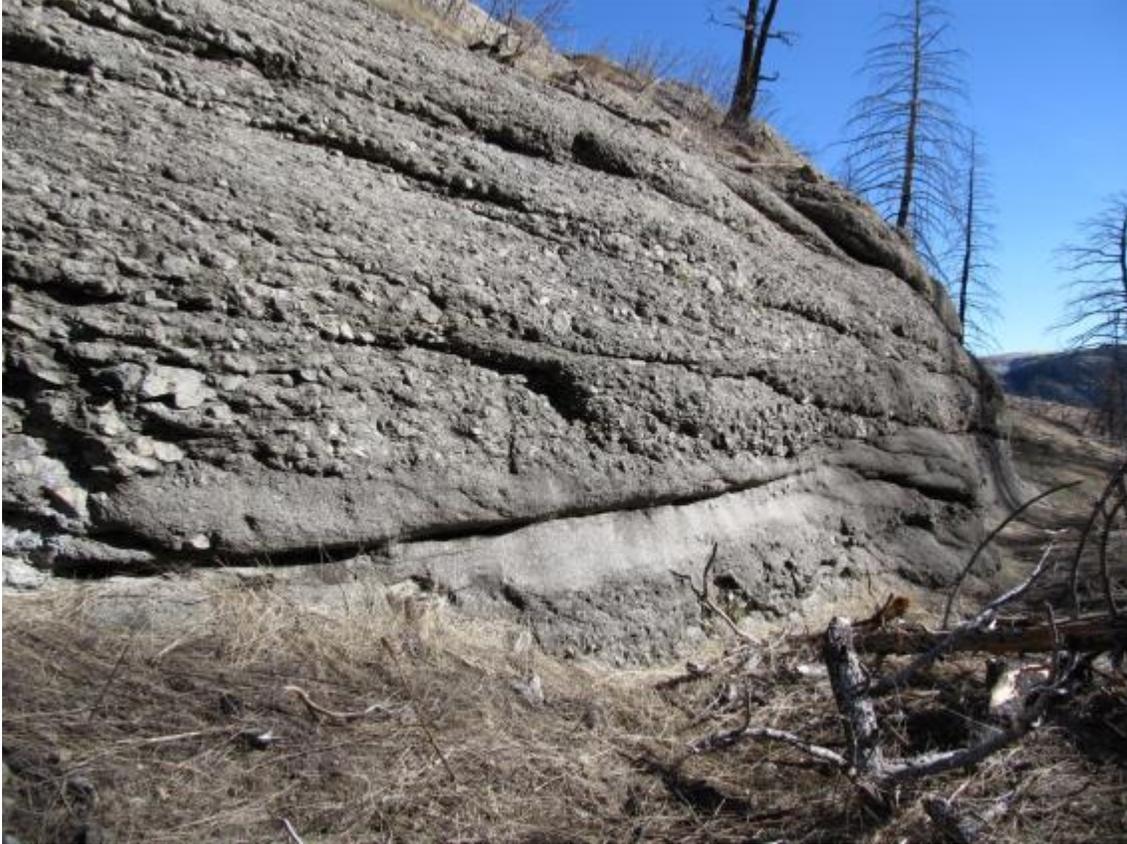
Figure 2. Nearly horizontal beds of the Sliderock Mountain formation. The light-colored bed at the bottom of the outcrop is coarse sand. It is overlain by thicker beds of conglomerate that contain visible pebbles. Kevin Chandler photo.

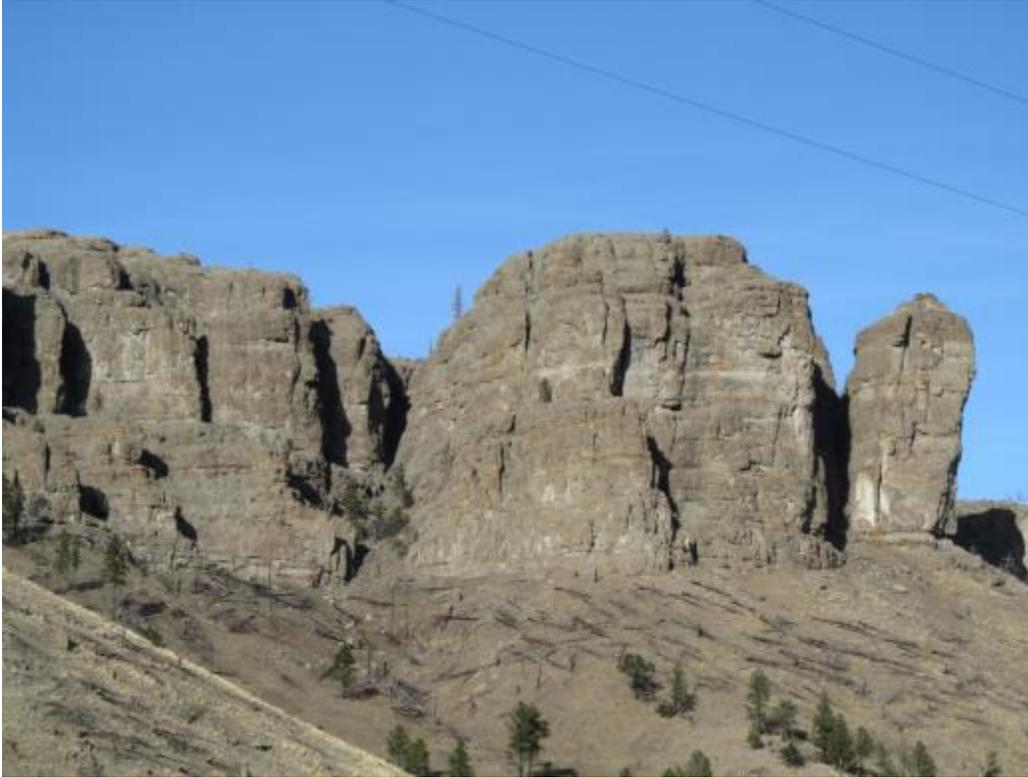
Figure 3. Cliffs formed in the Sliderock Mountain formation near Beehive, approximately one mile southwest of the rock fall site. Note nearly horizontal bedding and near-vertical cliff faces formed along the regional fracture pattern. Kevin Chandler photo.

These rocks are composed primarily of andesite (a silica-rich volcanic rock) erupted by a long-since eroded volcano near Sliderock Mountain, and redeposited as mud and debris flows to form the rock layers that are today exposed along the Stillwater River. Individual layers are as thin as a few inches to as much as tens of feet thick and composed of pebbles, cobbles and small boulders in a matrix of sand and silt (conglomerate). Some thin layers of coarse grained, poorly sorted, sandstone separate the thicker layers of conglomerate (Figure 2). As illustrated at locations approximately one mile southwest of the rock fall site, the layers are nearly horizontal, resistant to erosion, and form near-vertical cliffs along the Stillwater River canyon and side drainages (Figures 3 and 4).

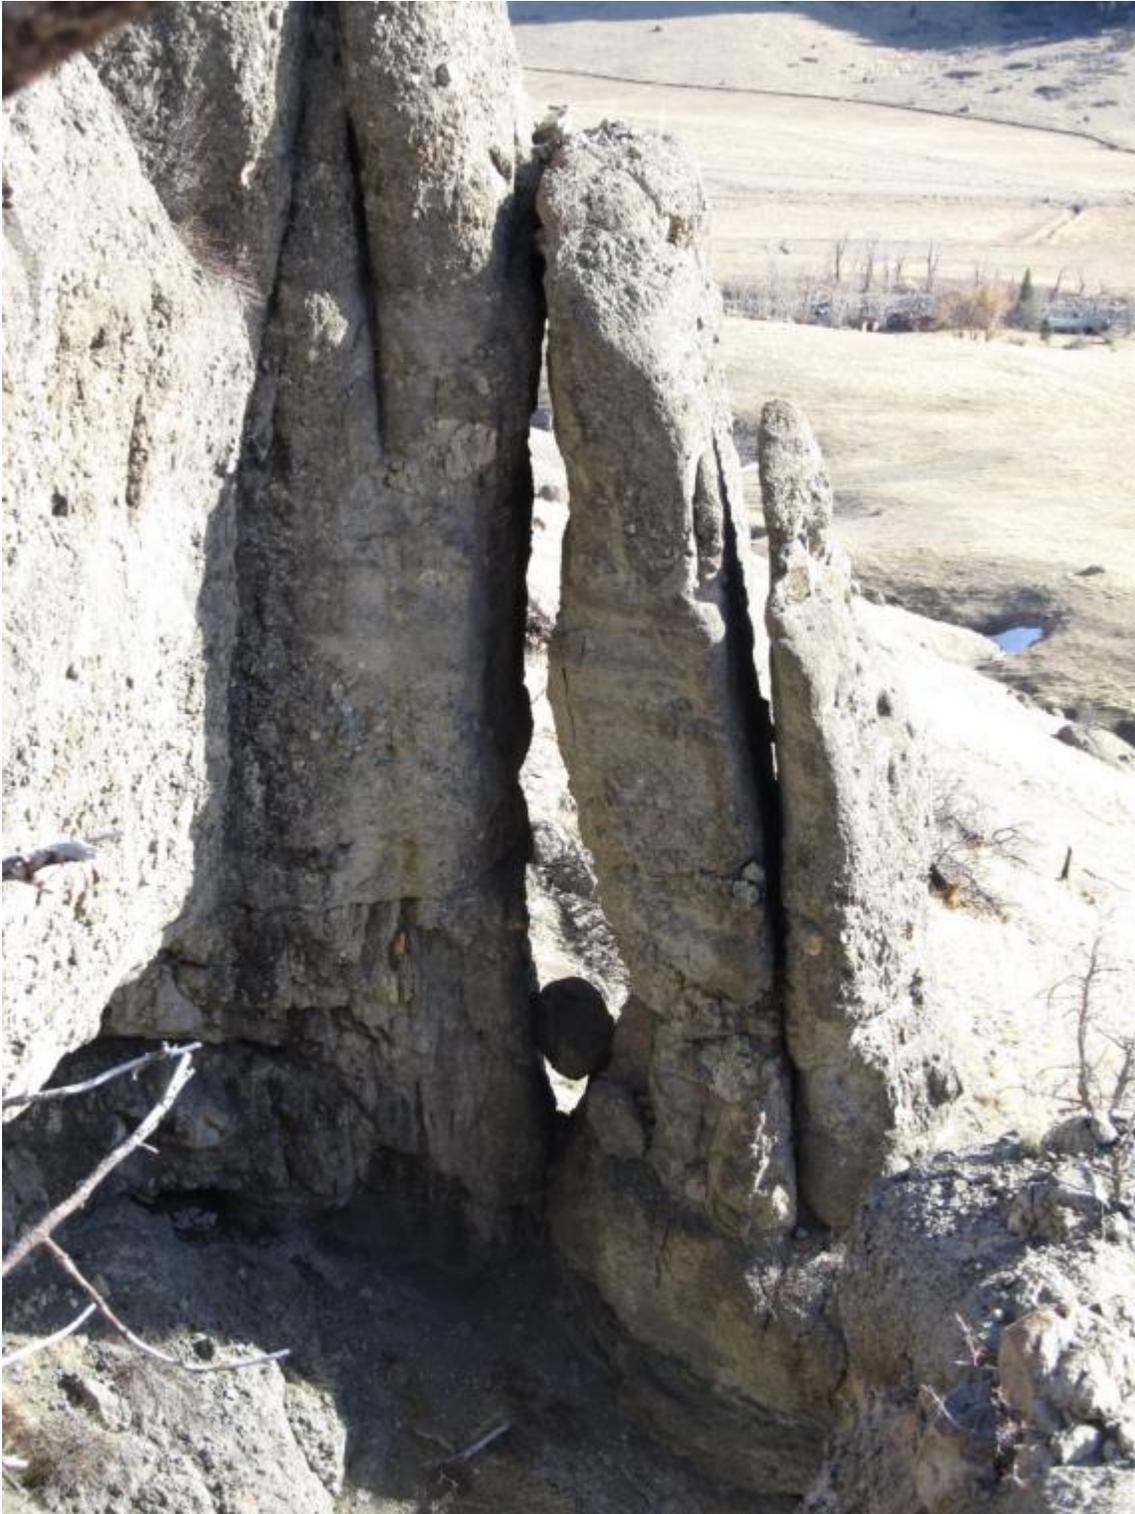
Figure 4. Rock pinnacles near Beehive illustrate weathering and erosion along fracture planes. Kevin Chandler photo.

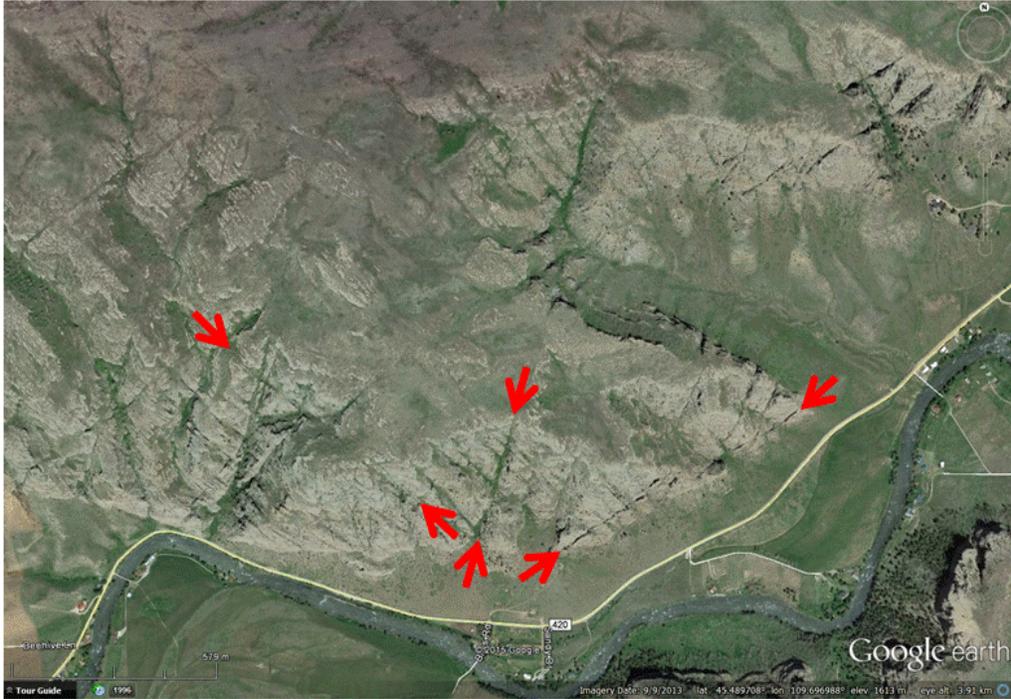
Figure 5. Three fracture-sets, clearly visible in bedrock approximately one mile southwest of the Stillwater River rock fall (better exposed here than at the rock fall site), trend  $N50^{\circ}W$ ,  $N20^{\circ}E$ , and  $N60^{\circ}E$ .

Three sets of fractures are visible on Google Earth imagery (Figure 5); one set trends N50°W, a second set trends N20°E, and the third set trends N60°E. In some cases, these fracture sets control the geometry of the cliff faces and produce the associated pinnacles. The N50°W-trending fracture set is subparallel to the Beartooth frontal fault, a reverse fault about three miles south of the rock fall site that bounds the northern edge of the Beartooth Mountains.
